**ASSABET RIVER BASIN  
ACTON, MASSACHUSETTS**

**ERIKSON DAM  
MA 00195**

# **PHASE I INSPECTION REPORT NATIONAL DAM INSPECTION PROGRAM**

**DECEMBER 1979**

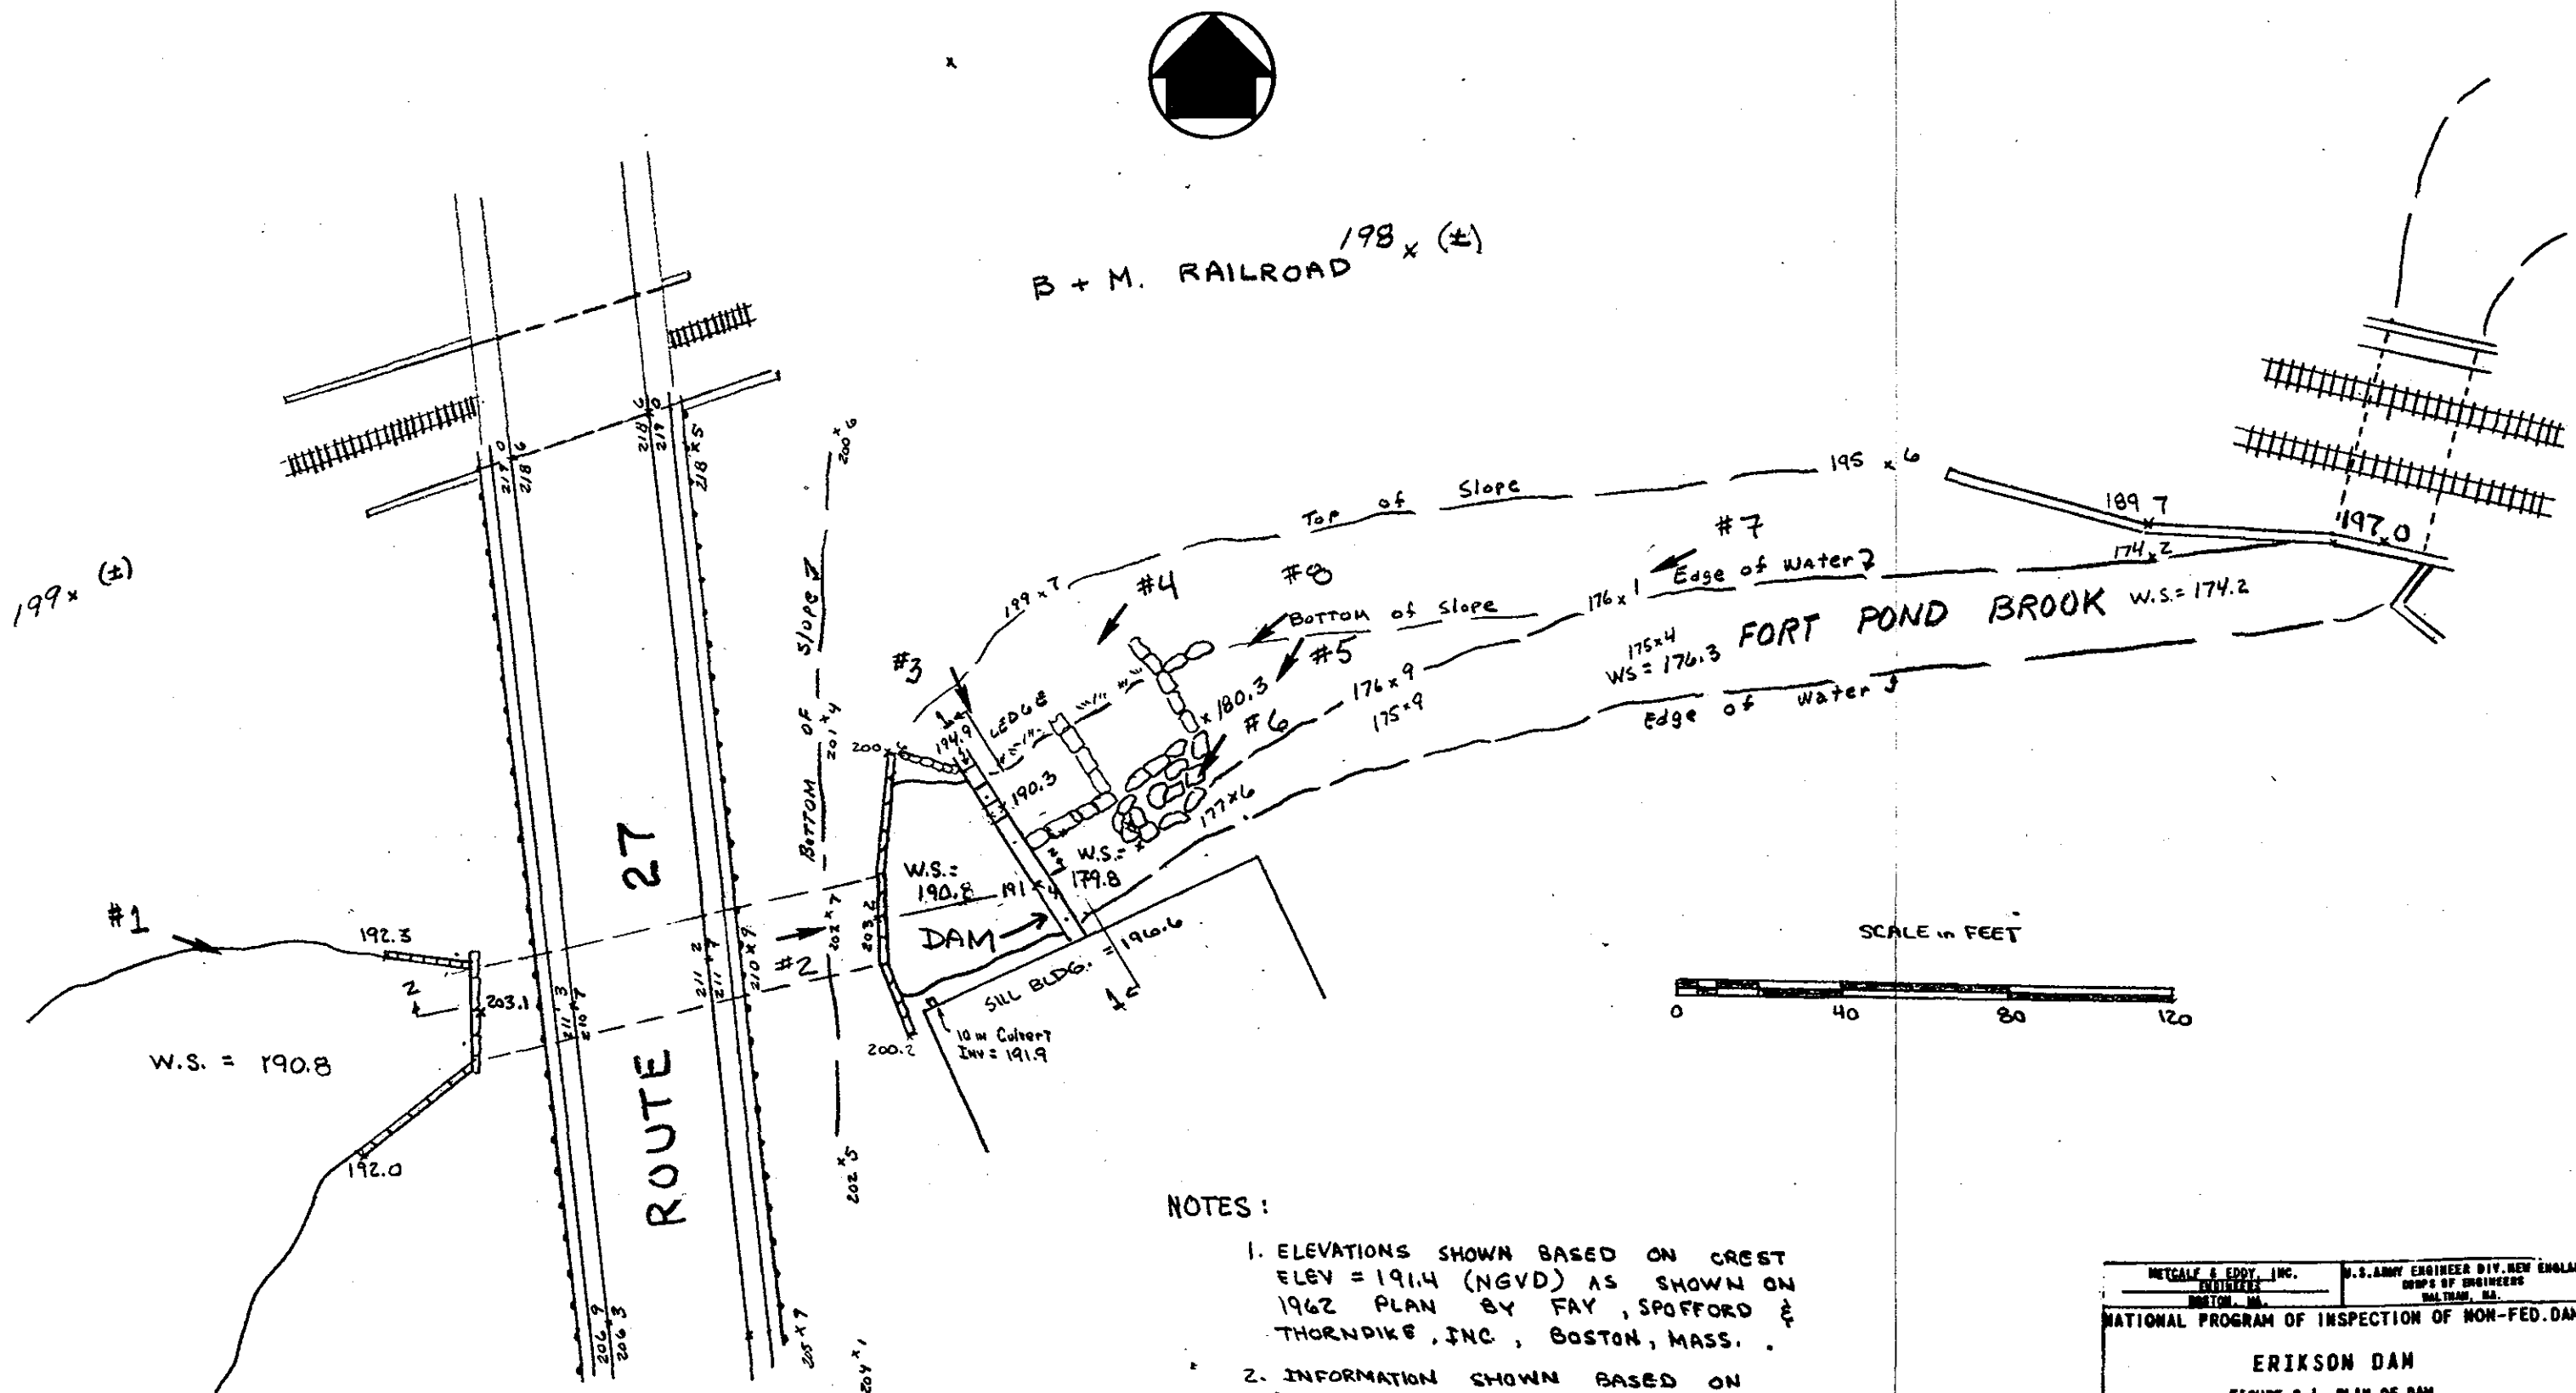
METCALF & EDDY, INC. DIVISION WASHINGTON, D.C.	U.S. ARMY ENGINEER DIVISION CORPS OF ENGINEERS WASHINGTON, D.C.
NATIONAL PROGRAM OF INSPECTION OF NON-FED. DAMS	
ERIKSON DAM FINISH D-S PROFILES THROUGH DAM AND ROUTE 27 CULVERT	
TRIBUTARY ACADET RIVER	MASSACHUSETTS
SCALE: 1" = 10'	DATE: SEPTEMBER, 1970
